Thermal Control System (TCS) Blanket Interference With Xo 378 Bulkhead Vent Ports

Lessons Learned: 2716

Anthony Chambers
Boeing Thermal Control Subsystem Manager
January 27, 2011

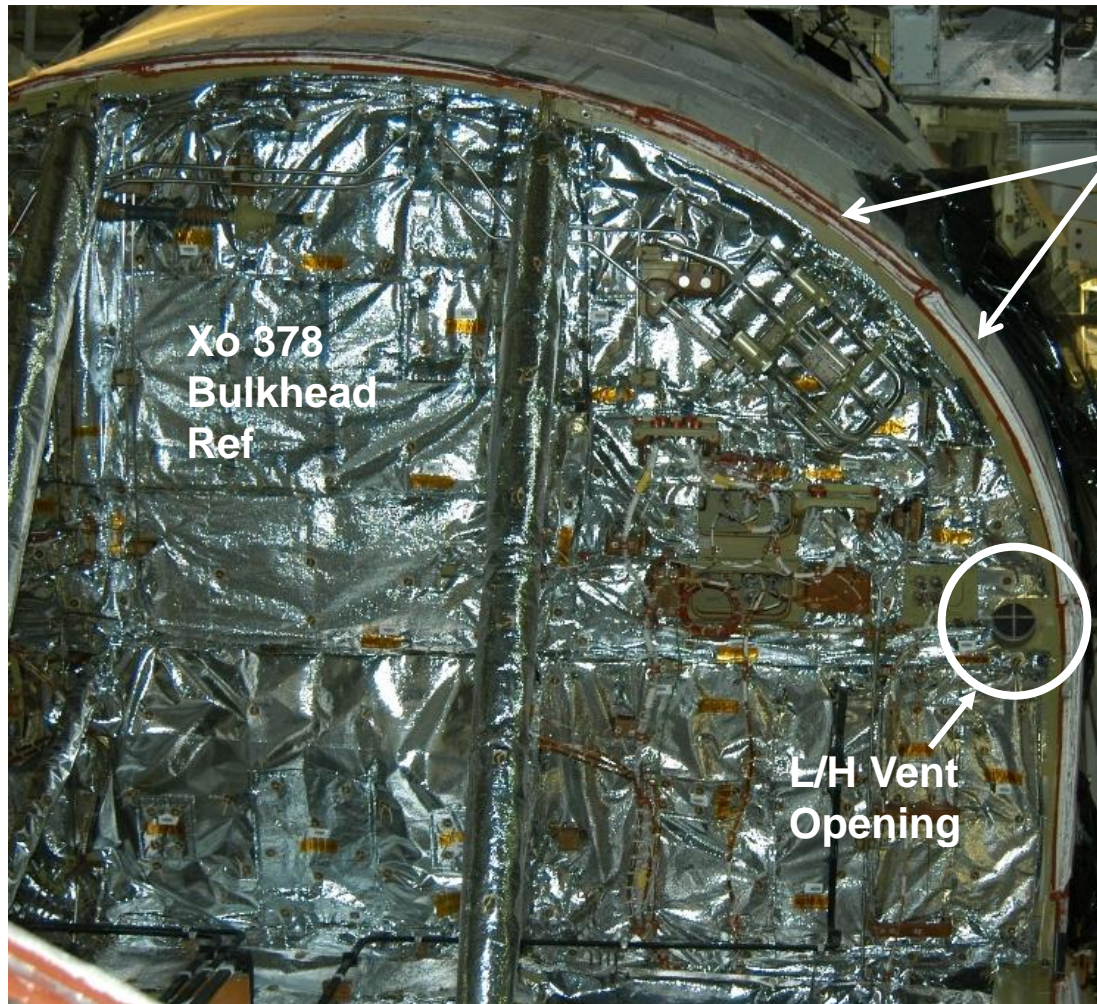
Looking Aft at Xo 378 Bulkhead

- Thermal Control Subsystem Blankets were installed incorrectly over the purge vent drain (PVD) lines on the Forward Reaction Control System (FRCS) module on OV-103.
- Incorrect installation allowed the TCS blankets to billow into the Xo 378 bulkhead vents, restricting venting of the FRCS cavity during STS-121 ascent.

**L/H Vent Opening on Xo 378 Bulkhead Shown
R/H Vent Opening Opposite and Symmetrical**

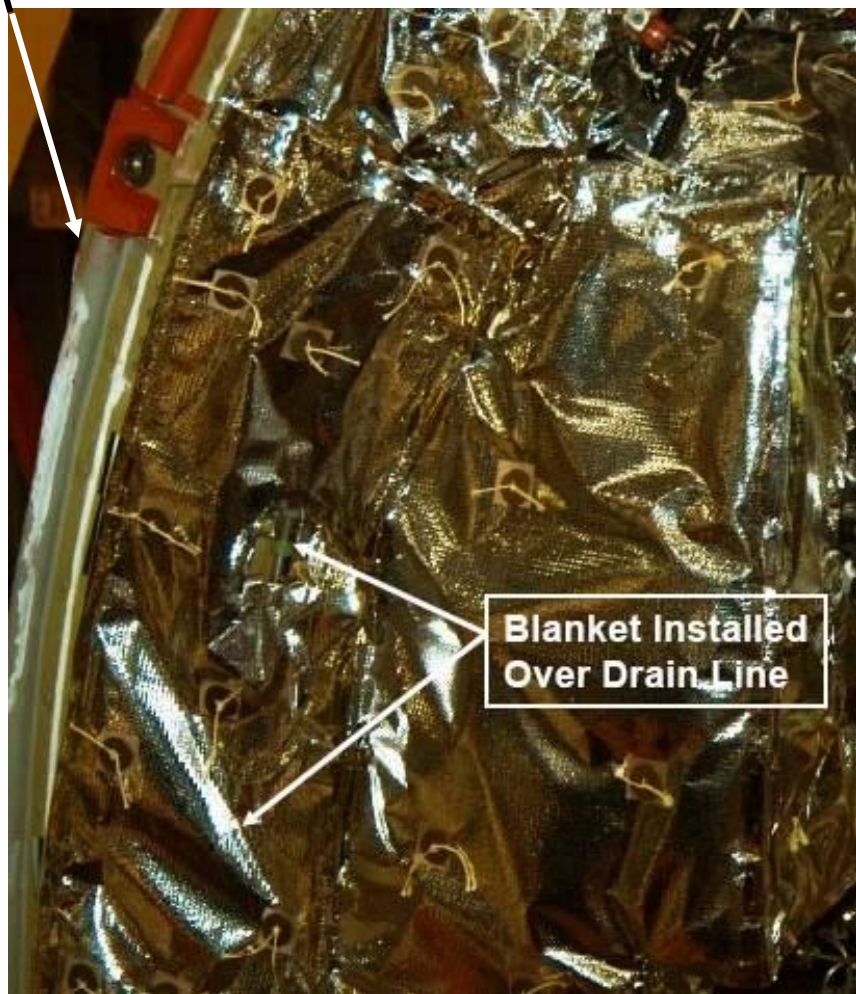
Blankets Over Drain Line (Incorrect)

- The blankets contain existing cutouts and cut lines, allowing installation under these lines.
 - Using templates to simulate a Xo378 vent port (on FRC5) TCS engineering determined that blockage of the vent ports can occur when blankets are installed on top of the drain lines.

- Improper installation of the TCS blankets was determined to be the cause of the vent anomaly.

- Drawing Correction:
 - specific migration Installation drawing V070-361900 was revised to provide blanket installation instructions in order to prevent blanket over the PVD purge vents on Xo 378.
 - Install blankets under drain lines
 - Tie to thruster box blankets using lacing cord and buttons
 - Tape to thruster box blankets along inboard seams
- Procedure Correction:
 - Blanket Installation/Removal Job Card V63-50049 was updated to provide detailed work steps, as well as cautions and warnings, requiring blanket installation under PVD drain lines.
- Blankets were installed/verified installed per new instructions on all FRCS modules.

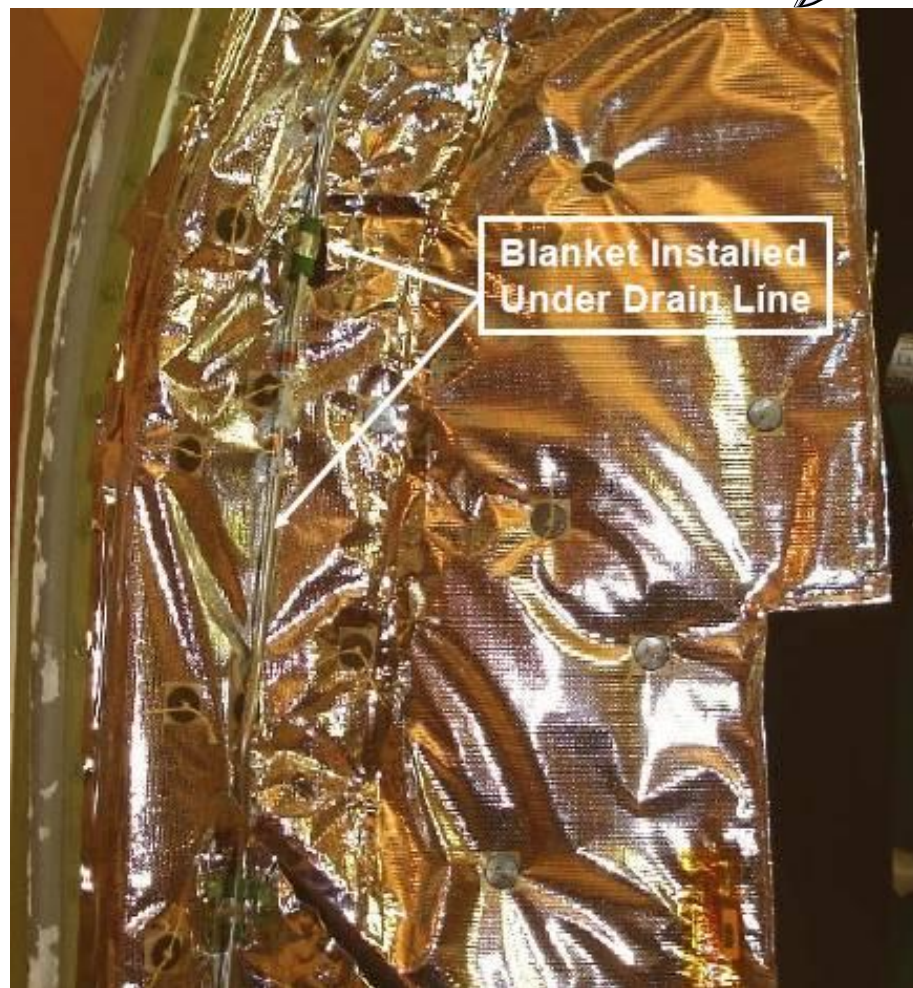
Blankets Under Drain Line (Correct)

- Design intent is to install the V070-361995-024 (LH) and V070-361995-025 (RH) MLI blankets under PVD drain lines in the FRCS.
 - When properly installed, the blankets are restrained by the PVD drain lines and cannot billow into the Xo 378 vent areas.
